# **FACTORS AFFECTING GASKET SELECTION FOR STAINLESS STEELS IN SEAWATER**

R Francis and G Byrne  
Weir Materials & Foundries  
Park Works  
Newton Heath  
Manchester M40 2BA  
UK

Keywords: seawater, crevice corrosion, stainless steels, gaskets.

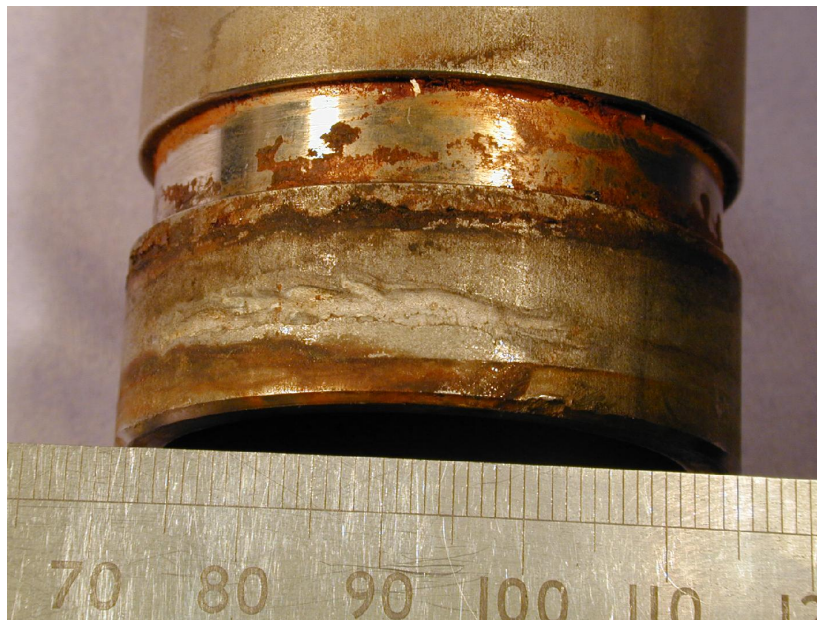
FIGURE 4 - Crevice corrosion of 316L at high pressure pipe joint.
